## **Mud Bay Geotechnical Services, LLC**

Job: 1988-LEW

Subject: Critical Area Hazard Geotechnical Report  
155 Evans Rd,  
Toledo, WA 98591  
Parcel #011489022000

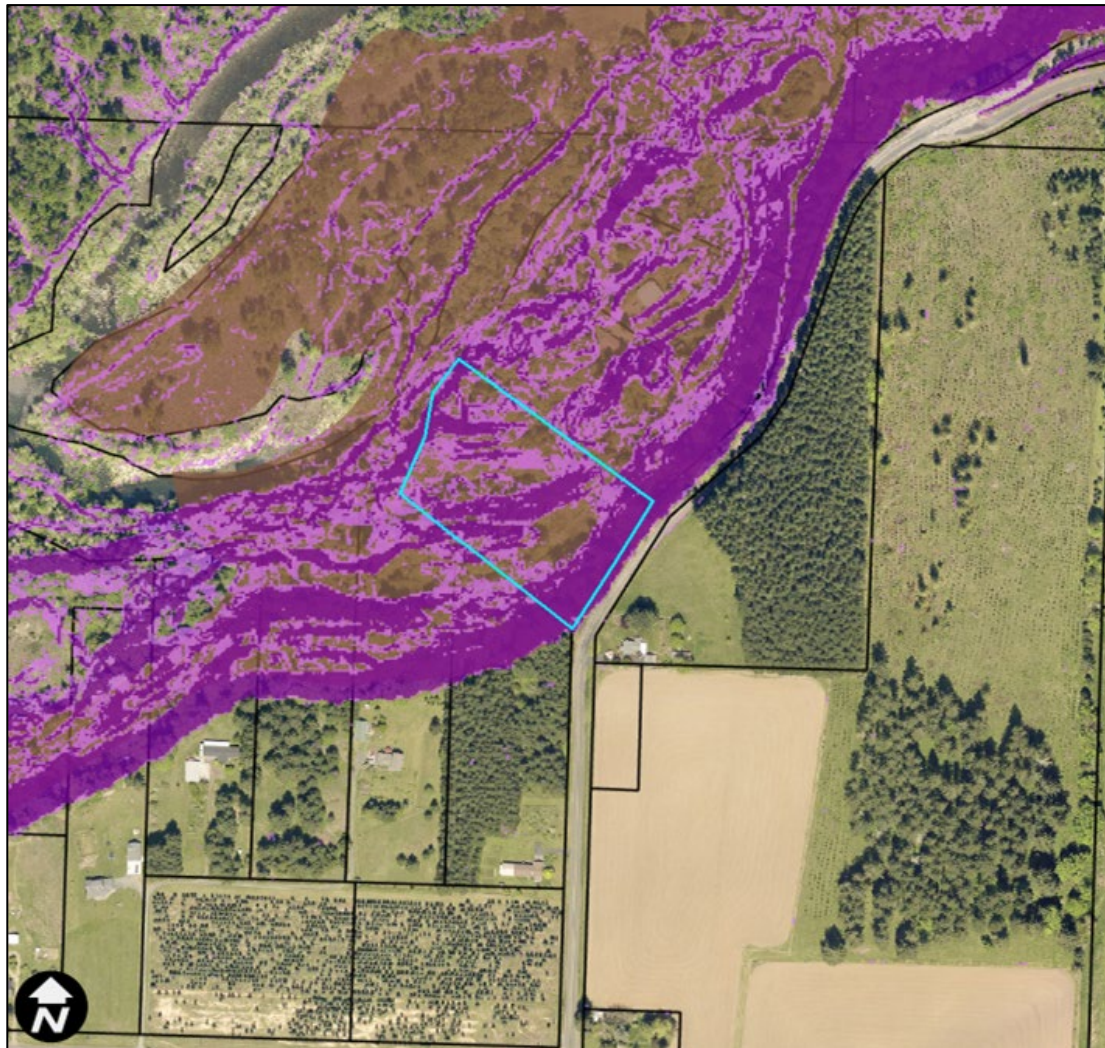
**Figure 1: Lewis GIS Hazard Map**

The subject parcel designated #011489022000 by Lewis County is mapped as a severe and very severe erosion hazard, and is positioned within steep slopes exceeding 35 percent, as designated on the attached Figure 1, Lewis GIS Hazard Map. The parcel is positioned off the northwest side of Evans Rd, within the steep slopes that transition between the upper glacial terrace and lower Cowlitz River Valley. The site location and approximate parcel location is delineated in the attached Figure 2, Site Location Map. The parcel is accessed via a private residential gravel road that enters the parcel from the northeast. The majority of the parcel is densely vegetated with native Pacific Northwest vegetation including middle to mature aged evergreen and deciduous trees, ferns, vines, and shrubbery.

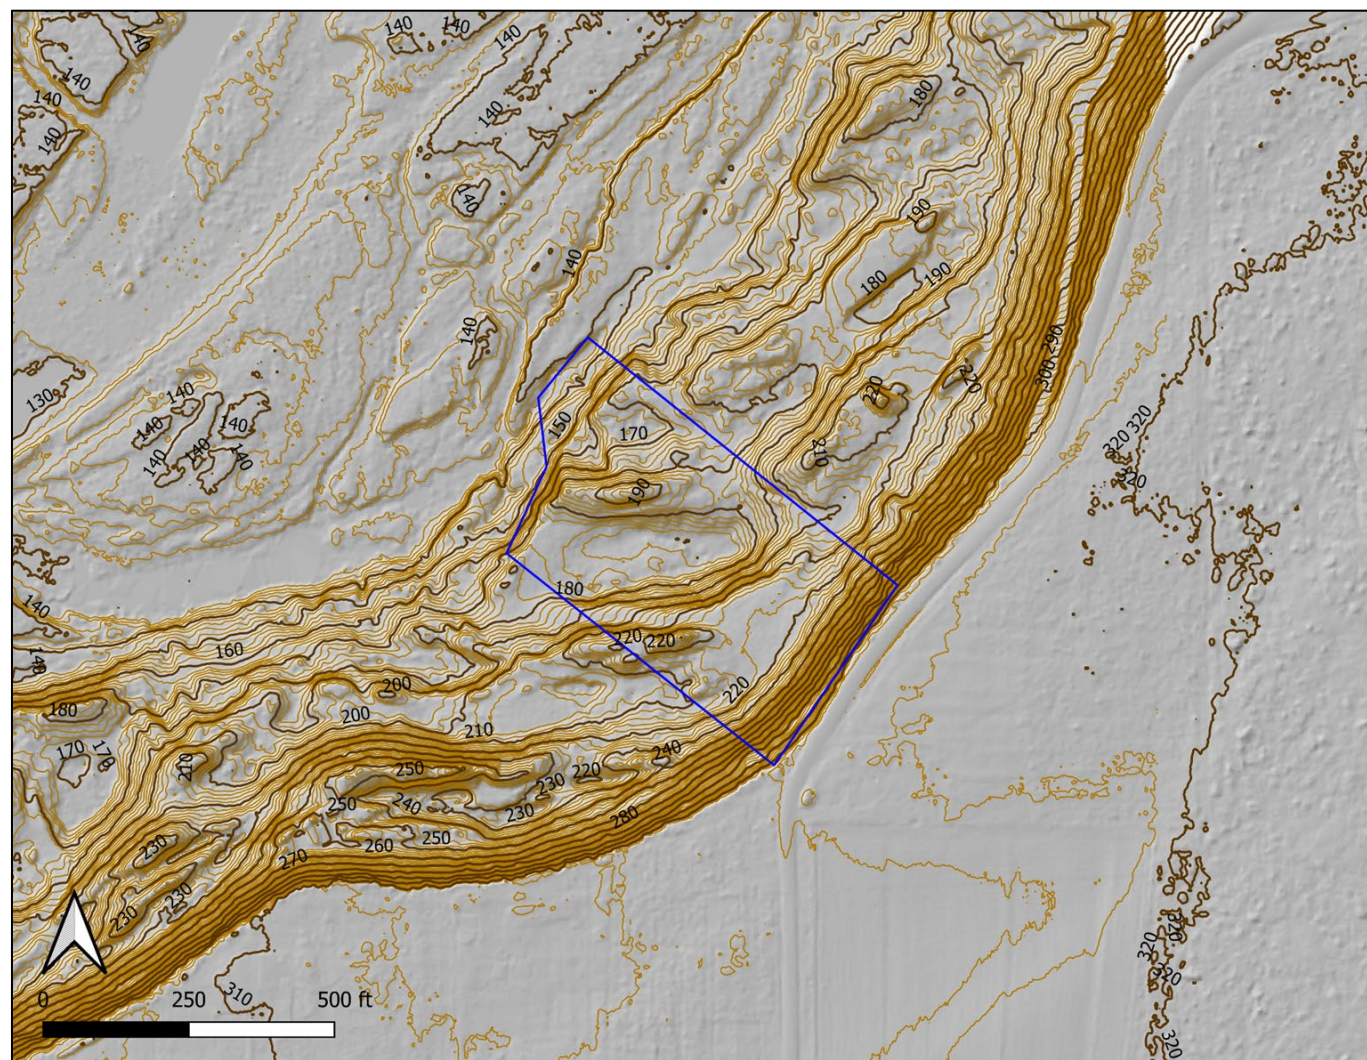
**Figure 8: QGIS Slope & Contour Map**

Slope values for the site can be seen in Figure 8, QGIS Slope & Contour Map. The slope percentage values are calculated using elevation data from the most recent LiDAR data available (2017). The slope calculations are expressed as a percentage, where the difference of two elevation points (rise) is divided by the distance between them (run) and then multiplied by 100. For reference, a slope percentage of 100% is equal to a 45° slope angle, where the *rise* is equal to the *run*. Figure 8 indicates that the steep slopes northwest of Evans Rd consist of slopes ranging from 100 to 200 percent, with portions of the slope exceeding 200 percent. The flat upper bench where the shop is proposed consists of slopes ranging from 0 to 15 percent. Downslope of the bench feature the slopes generally range from 35 to 100 percent. The minor slopes positioned north of the lower bench feature where the proposed log cabin home structure is to be located consist of slopes ranging from 15 to 35 percent that span a total elevation of 10 to 20 feet.

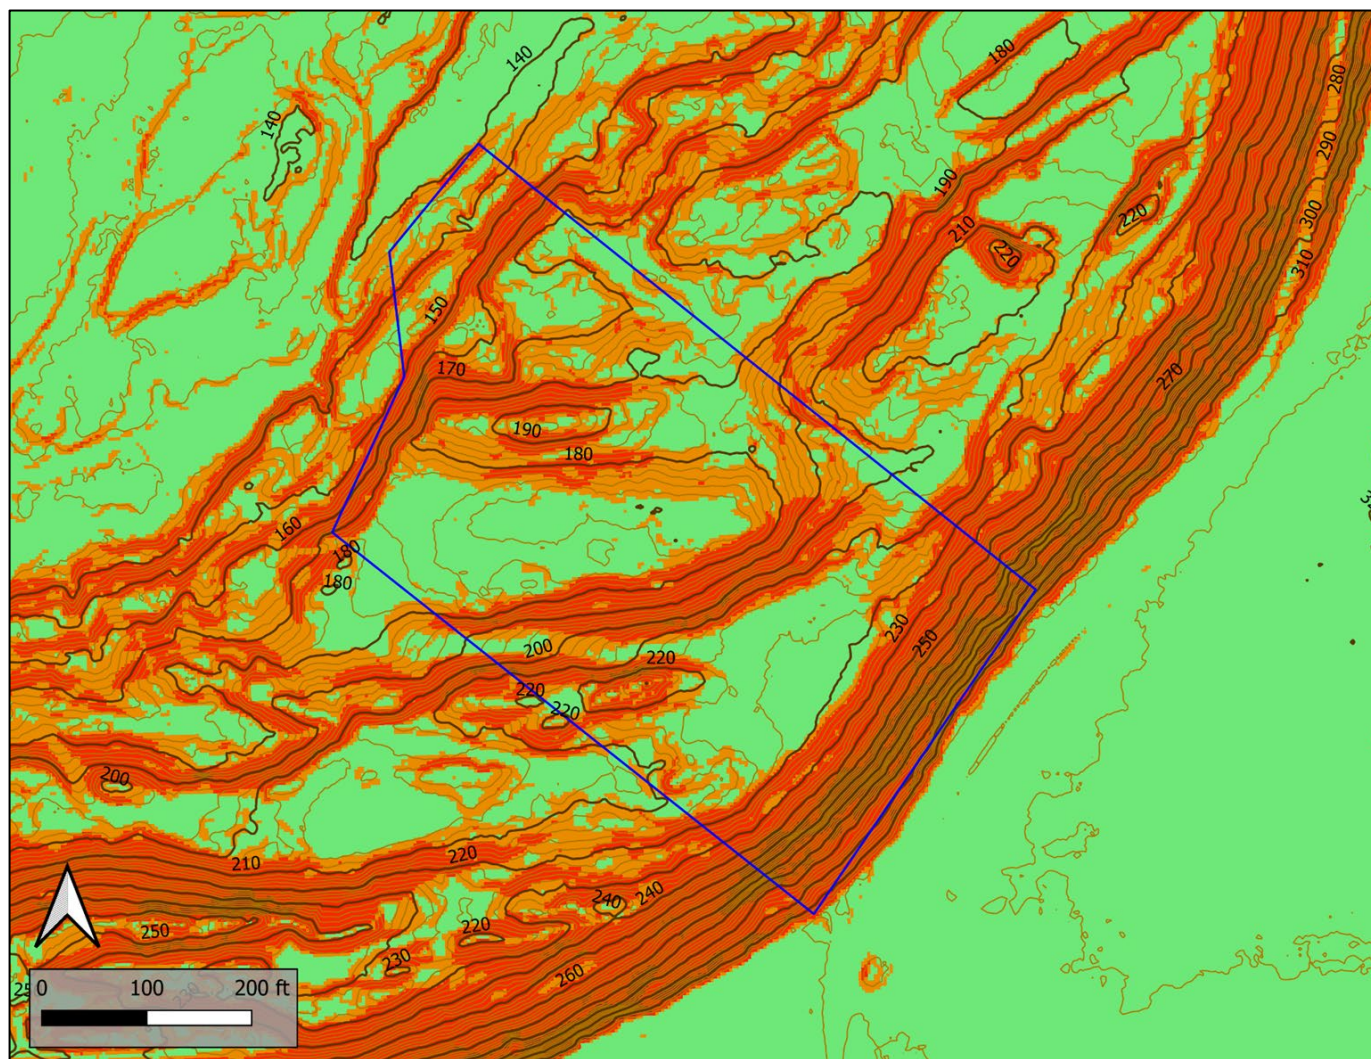
**Figure 9: QGIS Geologic Setback Map**

The attached Figure 13, QGIS Geologic Setback Map delineates the top and toe of slopes greater than 35% and spanning a total elevation loss of 15-feet or greater, and prescribes a setback distance of 25 feet from slopes meeting these criteria. The resulting CAHR Buffer Zone is also delineated. The setback distance was determined based on all of the information compiled for this report. Based on our site assessment and our understanding of the project, we believe a 25-foot setback to be sufficient to mitigate the risk of damage to the home or neighboring properties due to on-site geologic hazard. From our on-site investigation, no indications of past or present slope instability or other geologic hazards were noted in the subject parcel.
