## **Mud Bay Geotechnical Services, LLC**

Job: 1988-LEW

Subject: Critical Area Hazard Geotechnical Report  
155 Evans Rd,  
Toledo, WA 98591  
Parcel #011489022000

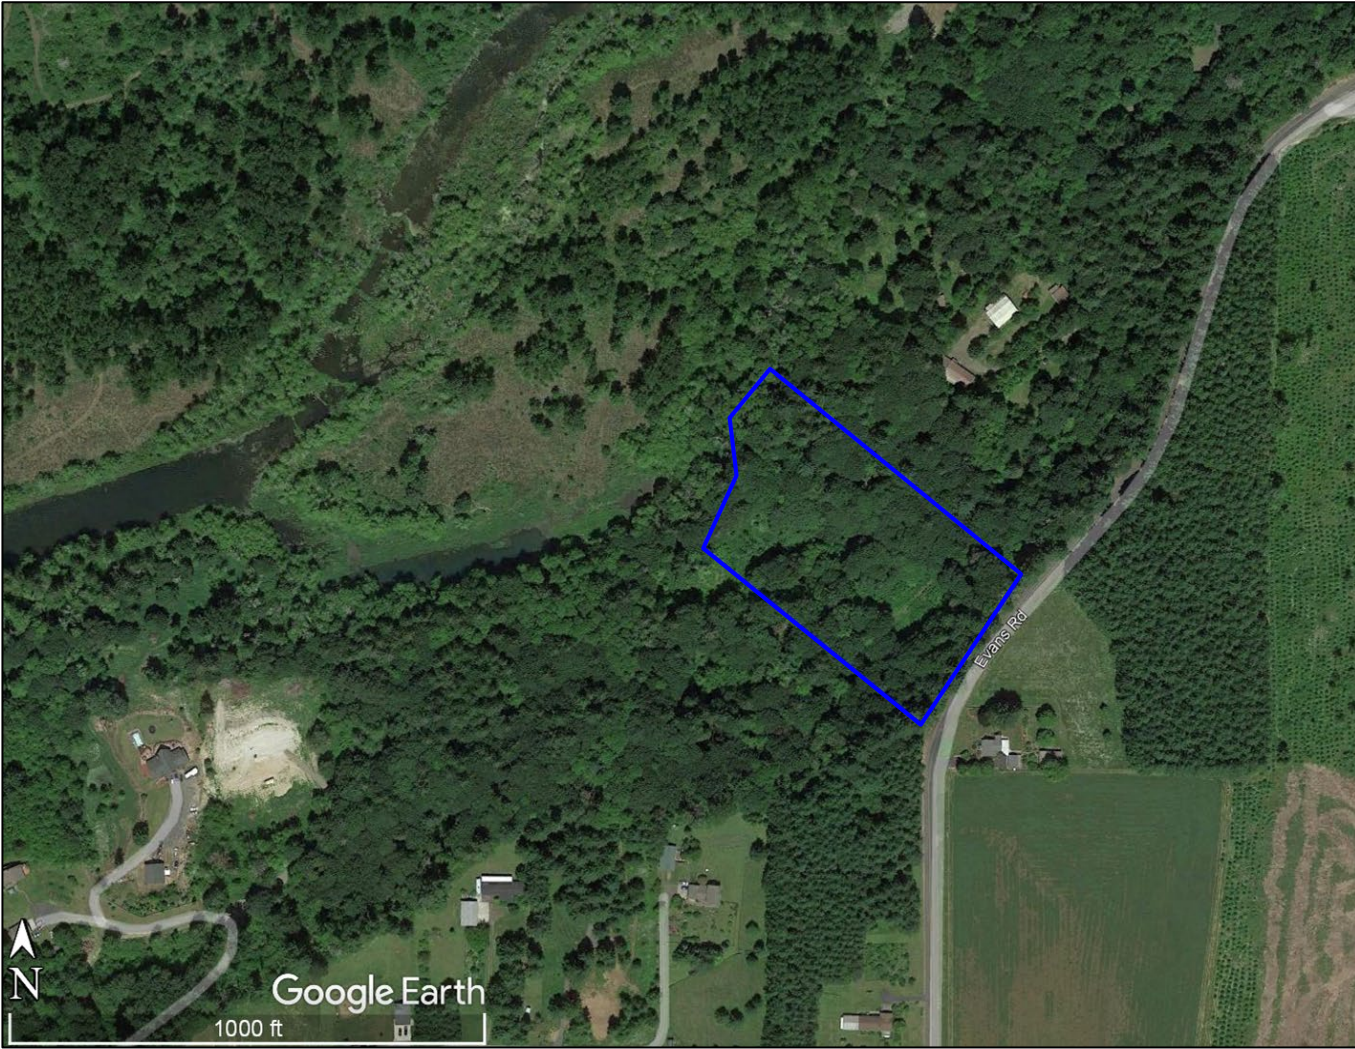
**Figure 1: Lewis GIS Hazard Map**

The subject parcel designated #011489022000 by Lewis County is mapped as a severe and very severe erosion hazard, and is positioned within steep slopes exceeding 35 percent, as designated on the attached Figure 1, Lewis GIS Hazard Map. The parcel is positioned off the northwest side of Evans Rd, within the steep slopes that transition between the upper glacial terrace and lower Cowlitz River Valley. The site location and approximate parcel location is delineated in the attached Figure 2, Site Location Map. The parcel is accessed via a private residential gravel road that enters the parcel from the northeast. The majority of the parcel is densely vegetated with native Pacific Northwest vegetation including middle to mature aged evergreen and deciduous trees, ferns, vines, and shrubbery.

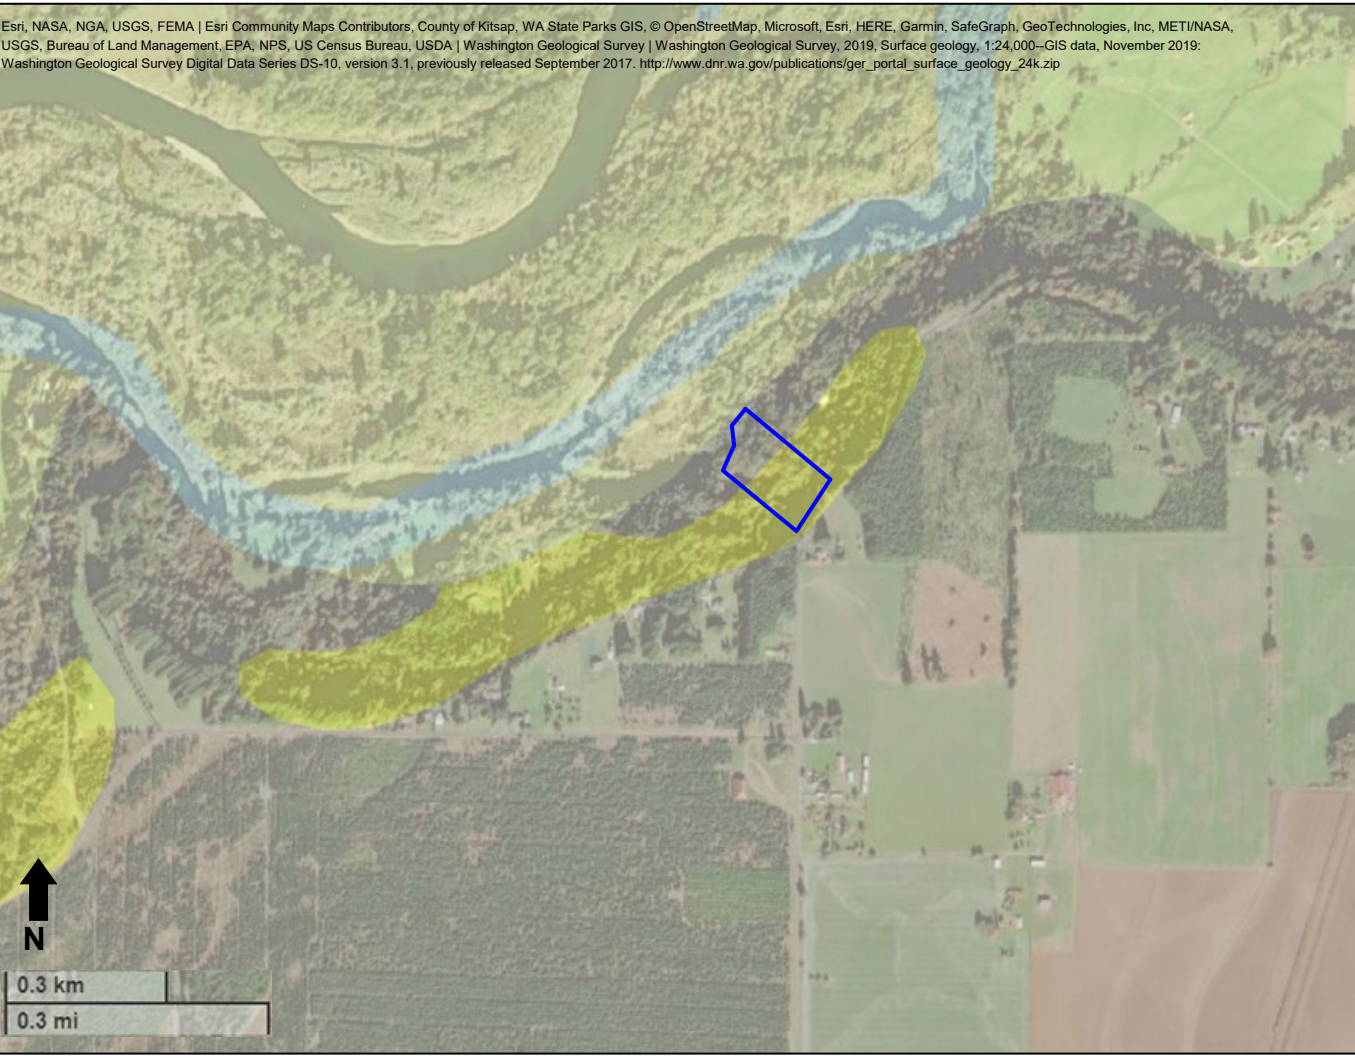
**Figure 3: WA DNR Geologic Map**  
155 Evans Rd,  
Toledo, WA 98591  
Critical Area Geotechnical Report

As part of this project, available geologic data from the Washington Department of Natural Resources (DNR) available at the 1:100,000 scale was reviewed, and a site-specific geologic map was prepared. The project vicinity geologic map is attached as Figure 3, WA DNR Geologic Map. This figure indicates the project vicinity consists of Quaternary alluvium associated with the Cowlitz River Valley. Mapped directly on-site are Quaternary mass wasting deposits associated with the steep slope environment in the parcel's southeastern half, and Pleistocene alpine glacial drift in the parcel's lower, northwestern half. Conditions observed at the site are generally consistent with the mapped geology at the site.

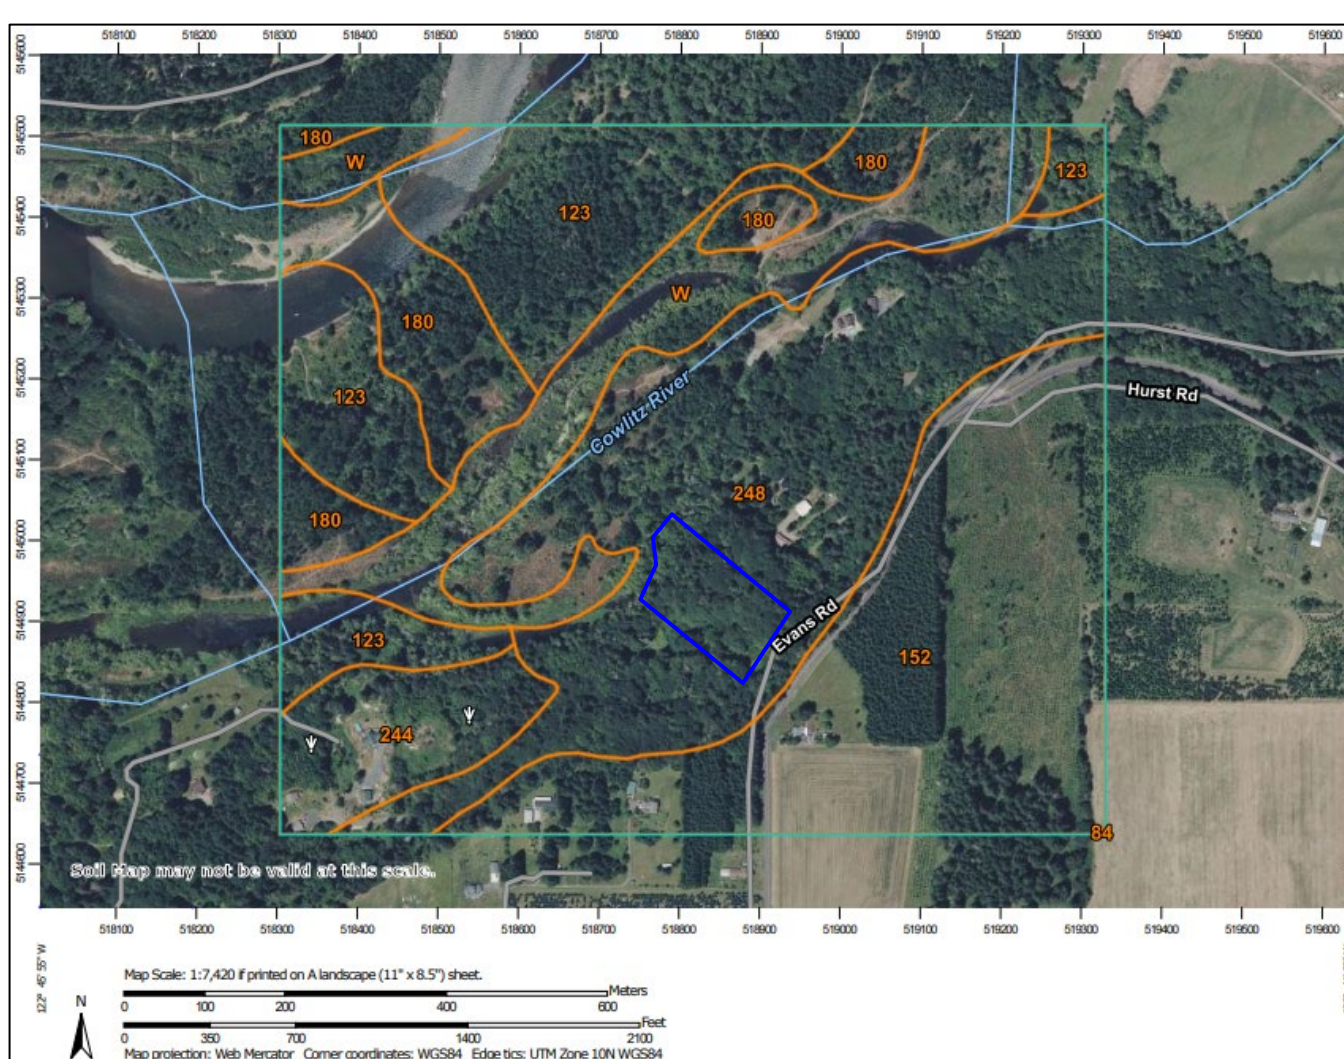
**Figure 4: USDA Soil Map**

Along with the site geology, soil data was also reviewed and is represented in Figure 4, USDA Soil Map. The soil in the parcel was mapped by the United States Department of Agriculture,

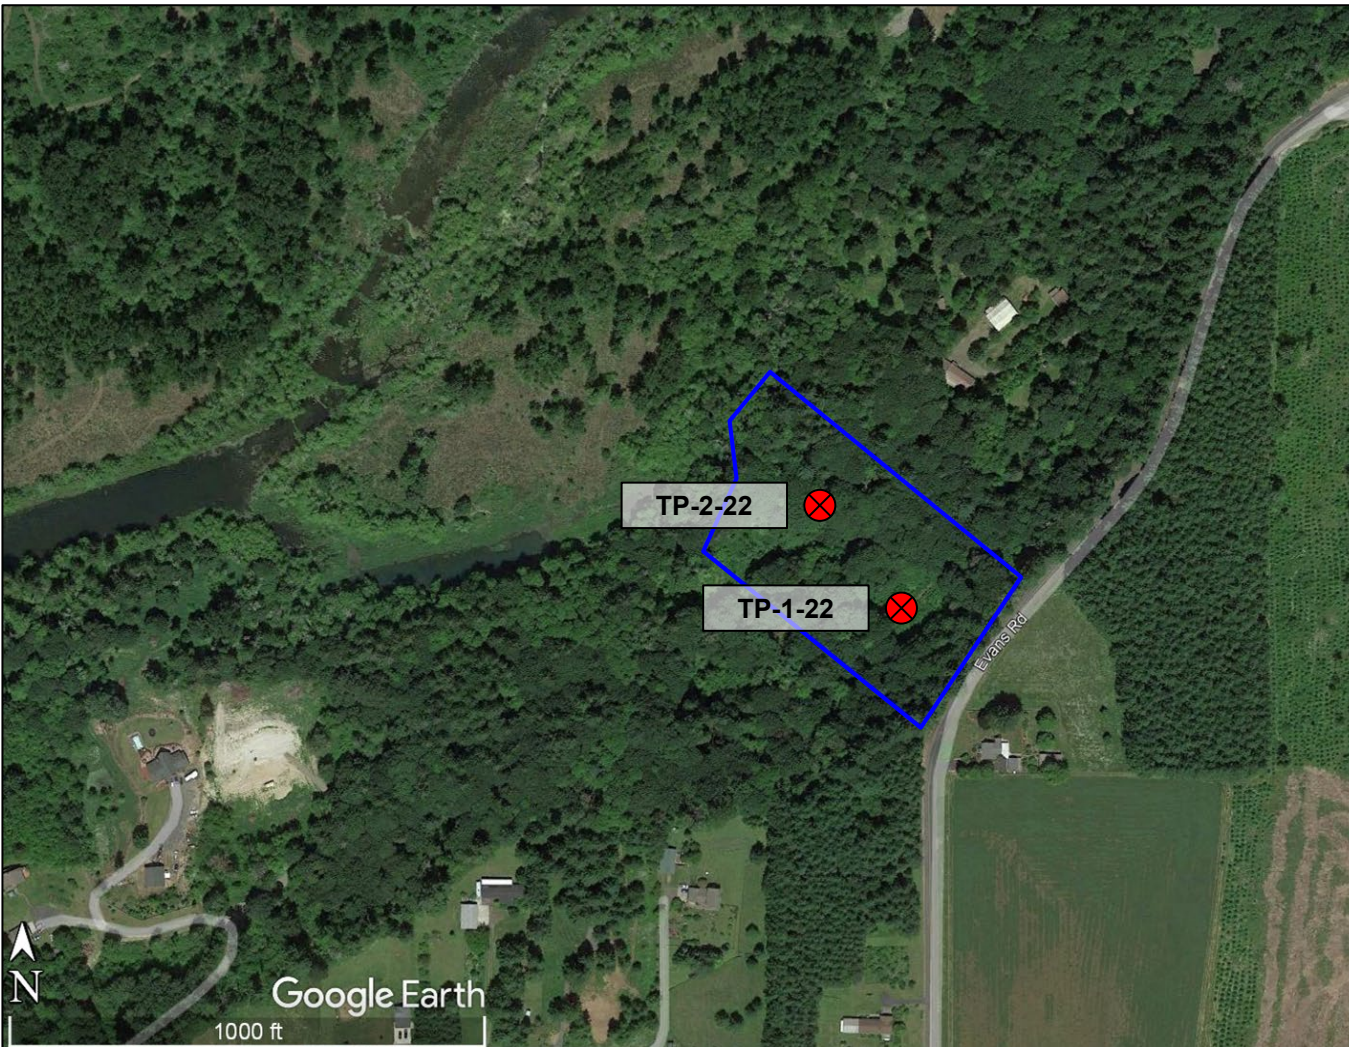
**Figure 5: Site Exploration Map**

The test pits completed for the subject project were designated TP-1-22 and TP-2-22. TP-1-22 was performed in the upper bench feature where the proposed shop feature will be located. TP-2-22 was performed within the lower portion of the site where the proposed log cabin home structure will be constructed. The approximate location of the test pits are shown in the attached Figure 5, Site Exploration Map.
